MASH Test Nos. 3-17 and 3-11 on a Non-Proprietary Cable Median Barrier

*Midwest States Regional Pooled Fund Research Program
Fiscal Years 2012 and 2014 (Years 22 and 24)
Research Project Number TPF-5(193) sup. 44 and sup. 64
NDOR Sponsoring Agency Code RFP-14-CABLE-1*

MASH TEST NOS. 3-17 AND 3-11 ON A NON-PROPRIETARY CABLE MEDIAN BARRIER

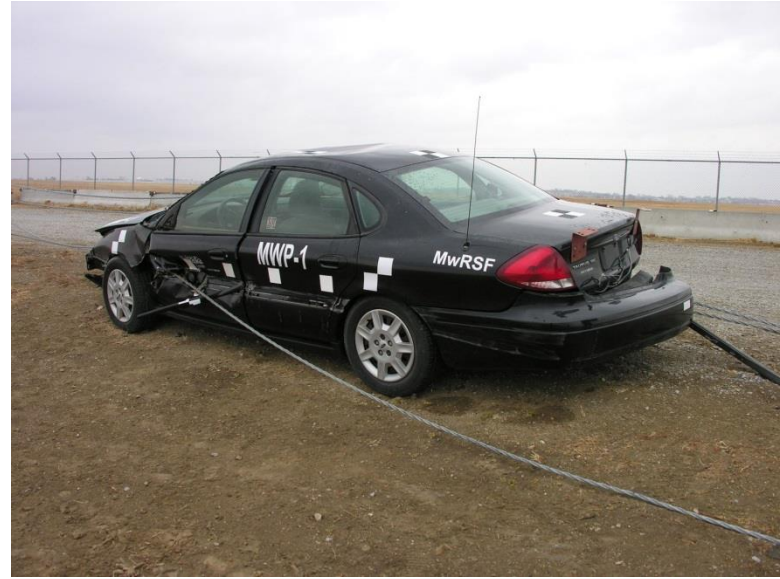
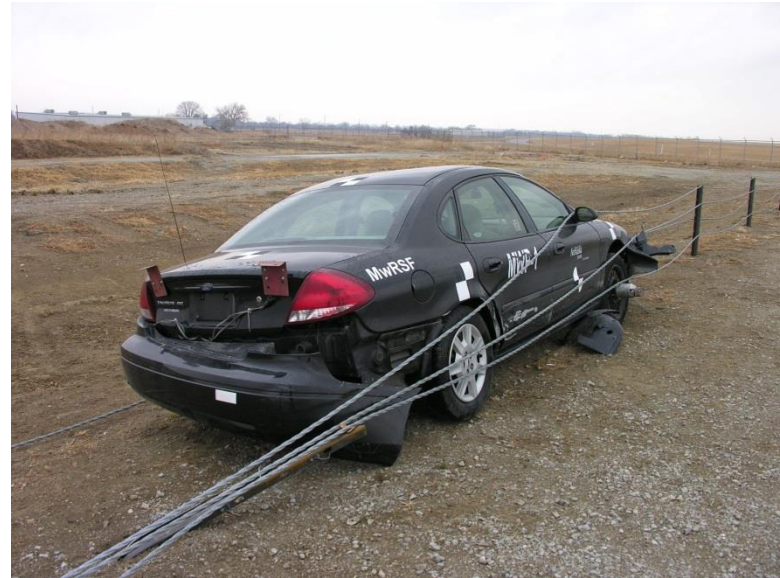
Figure 51. Vehicle Damage, Test No. MWP-1

The damage to the vehicle was moderate, as shown in Figures 51 through 53. The maximum occupant compartment deformations are listed in Table 6 along with the deformation limits established in MASH for various areas of the occupant compartment. Note that none of the MASH-established deformation limits were violated. Complete occupant compartment and vehicle deformations and the corresponding locations are provided in Appendix D.

The majority of the vehicle damage was concentrated on the left-front corner and left side of the vehicle where the impact occurred. The front bumper was under the front of the car. The left-front fender disengaged from the front bumper. There was a 2½-in. (64-mm) gap at the left headlight on the fender. The left-front tire was torn and a 10½-in. (267-mm) tear was located on the left-front fender. There were scrapes and gouges along the left side of the vehicle. Gouges were present along the A-pillar, and there were multiple cracks along the left side of the windshield. The left-side mirror was disengaged. There was a 6-in. (152-mm) wide, 32-in. (813-mm) long tear in the left-front door, starting at the back of the left-front fender and continuing along the left side of the car. The roof was scraped from the cables and was indented 2½ in. (64 mm). There was a 12-in. (305-mm) long dent on the right-rear quarter panel. The right side of the vehicle was scraped, including the right-front rim. The right-front bumper was crushed around post no. 28. The right-front headlight was broken but still attached. The remaining window glass remained undamaged. Minor scrapes were found on the undercarriage along the engine and transmission oil pans, control arms, exhaust pipe, and driver's side floor pan. A 23-in. (584-mm) long and ¼-in. (6.4-mm) deep gouge was located on the fuel tank.
